REPORT OF WATER QUALITY IN BIG CLEAR LAKE

1972

Ministry
of the
Environment

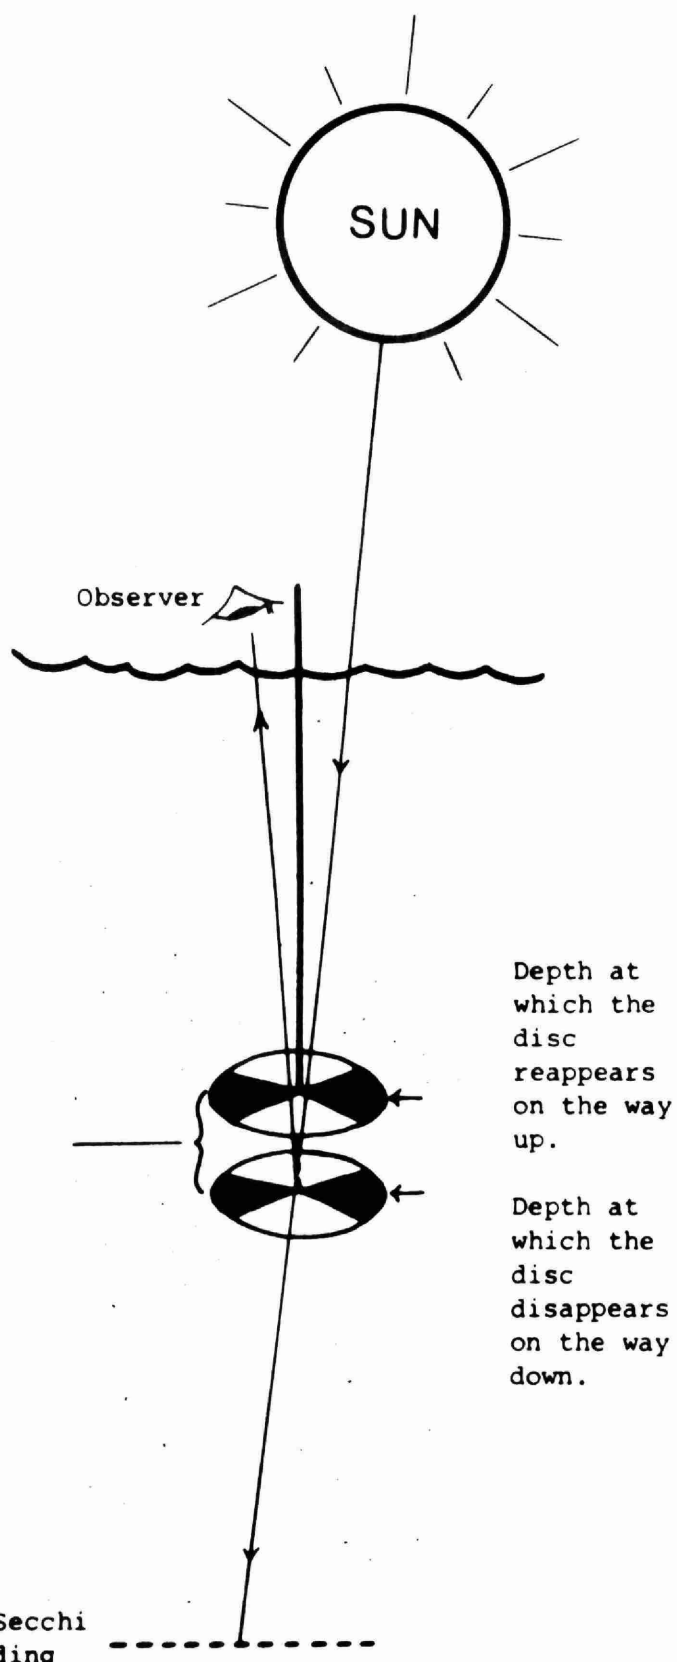
Figure 1: USE OF SECCHI DISC TO DETERMINE WATER CLARITY

The "Secchi Disc Reading" is obtained by averaging the depth at which a 23cm (9") dia. black and white plate, lowered into the lake just disappears from view and the depth where it reappears as it is pulled up.

Most of the free-floating algae are suspended in the illuminated region between the lake surface and 2 times the Secchi disc reading.

Clear, algae-free lake:
Secchi disc readings tend to be greater than 3m (9 feet).

Turbid or algae-rich lake:
Secchi disc readings tend to be less than 3m (9 feet).

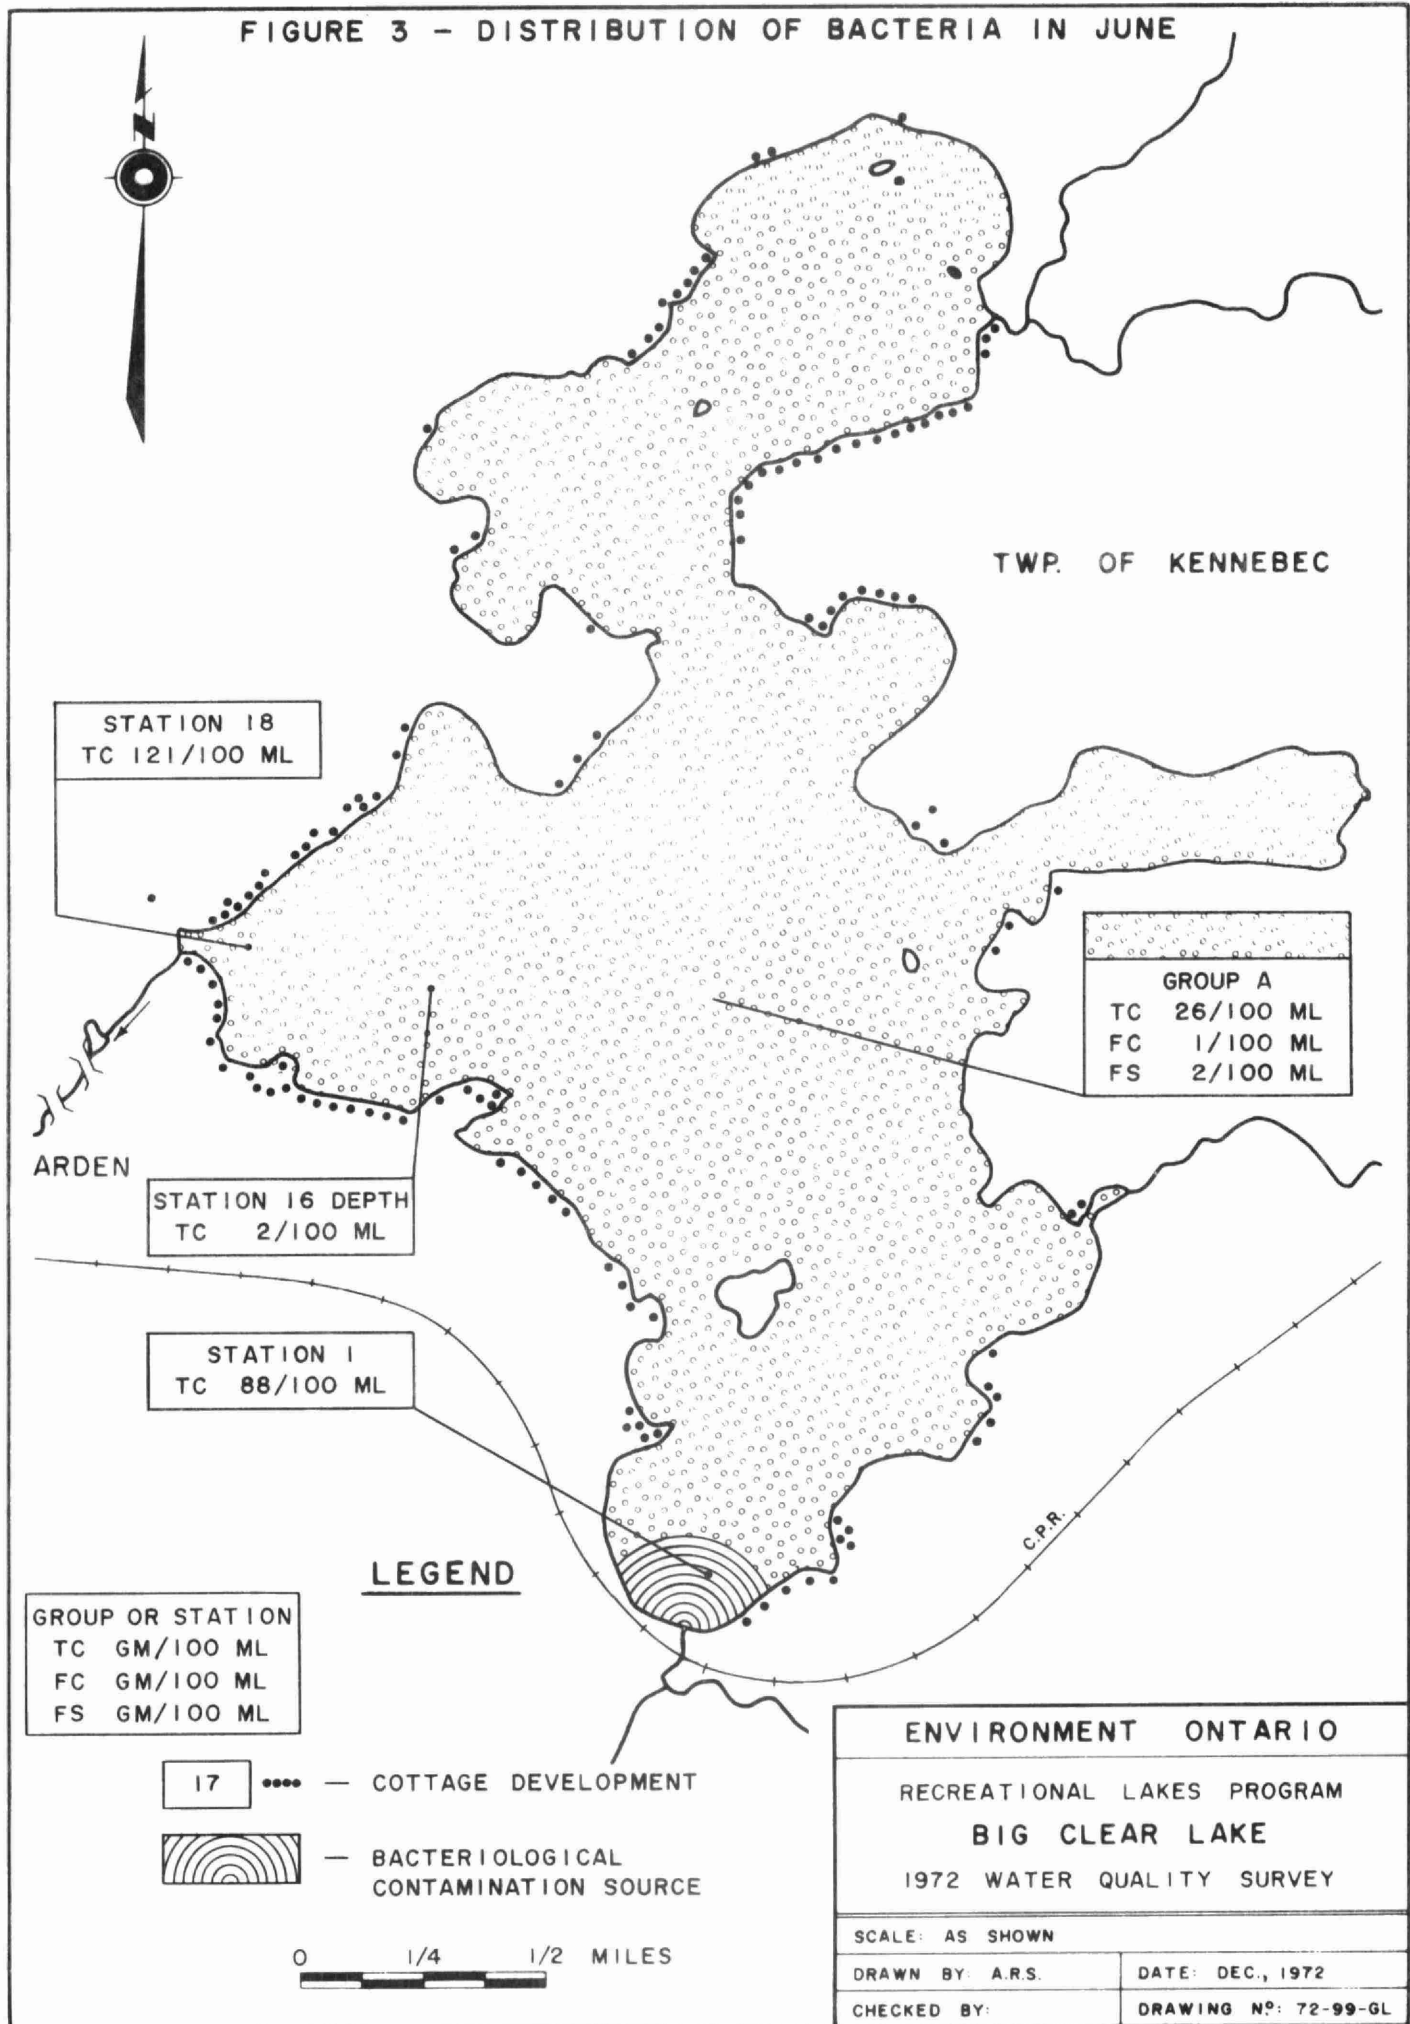
FIGURE 3 - DISTRIBUTION OF BACTERIA IN JUNE

In June, total coliform (TC), fecal coliform (FC) and fecal streptococcus (FS) mean values were 26, 1, and 2/100 ml respectively for the majority of stations on the lake (Group A), (Figure 3). While FC and FS mean densities were homogeneous for all stations over the entire lake, TC mean densities

fluctuated slightly. The south-west tip of the lake with moderate cottage development (Station 1) displayed a higher mean of 88 TC/100 ml than Group A.

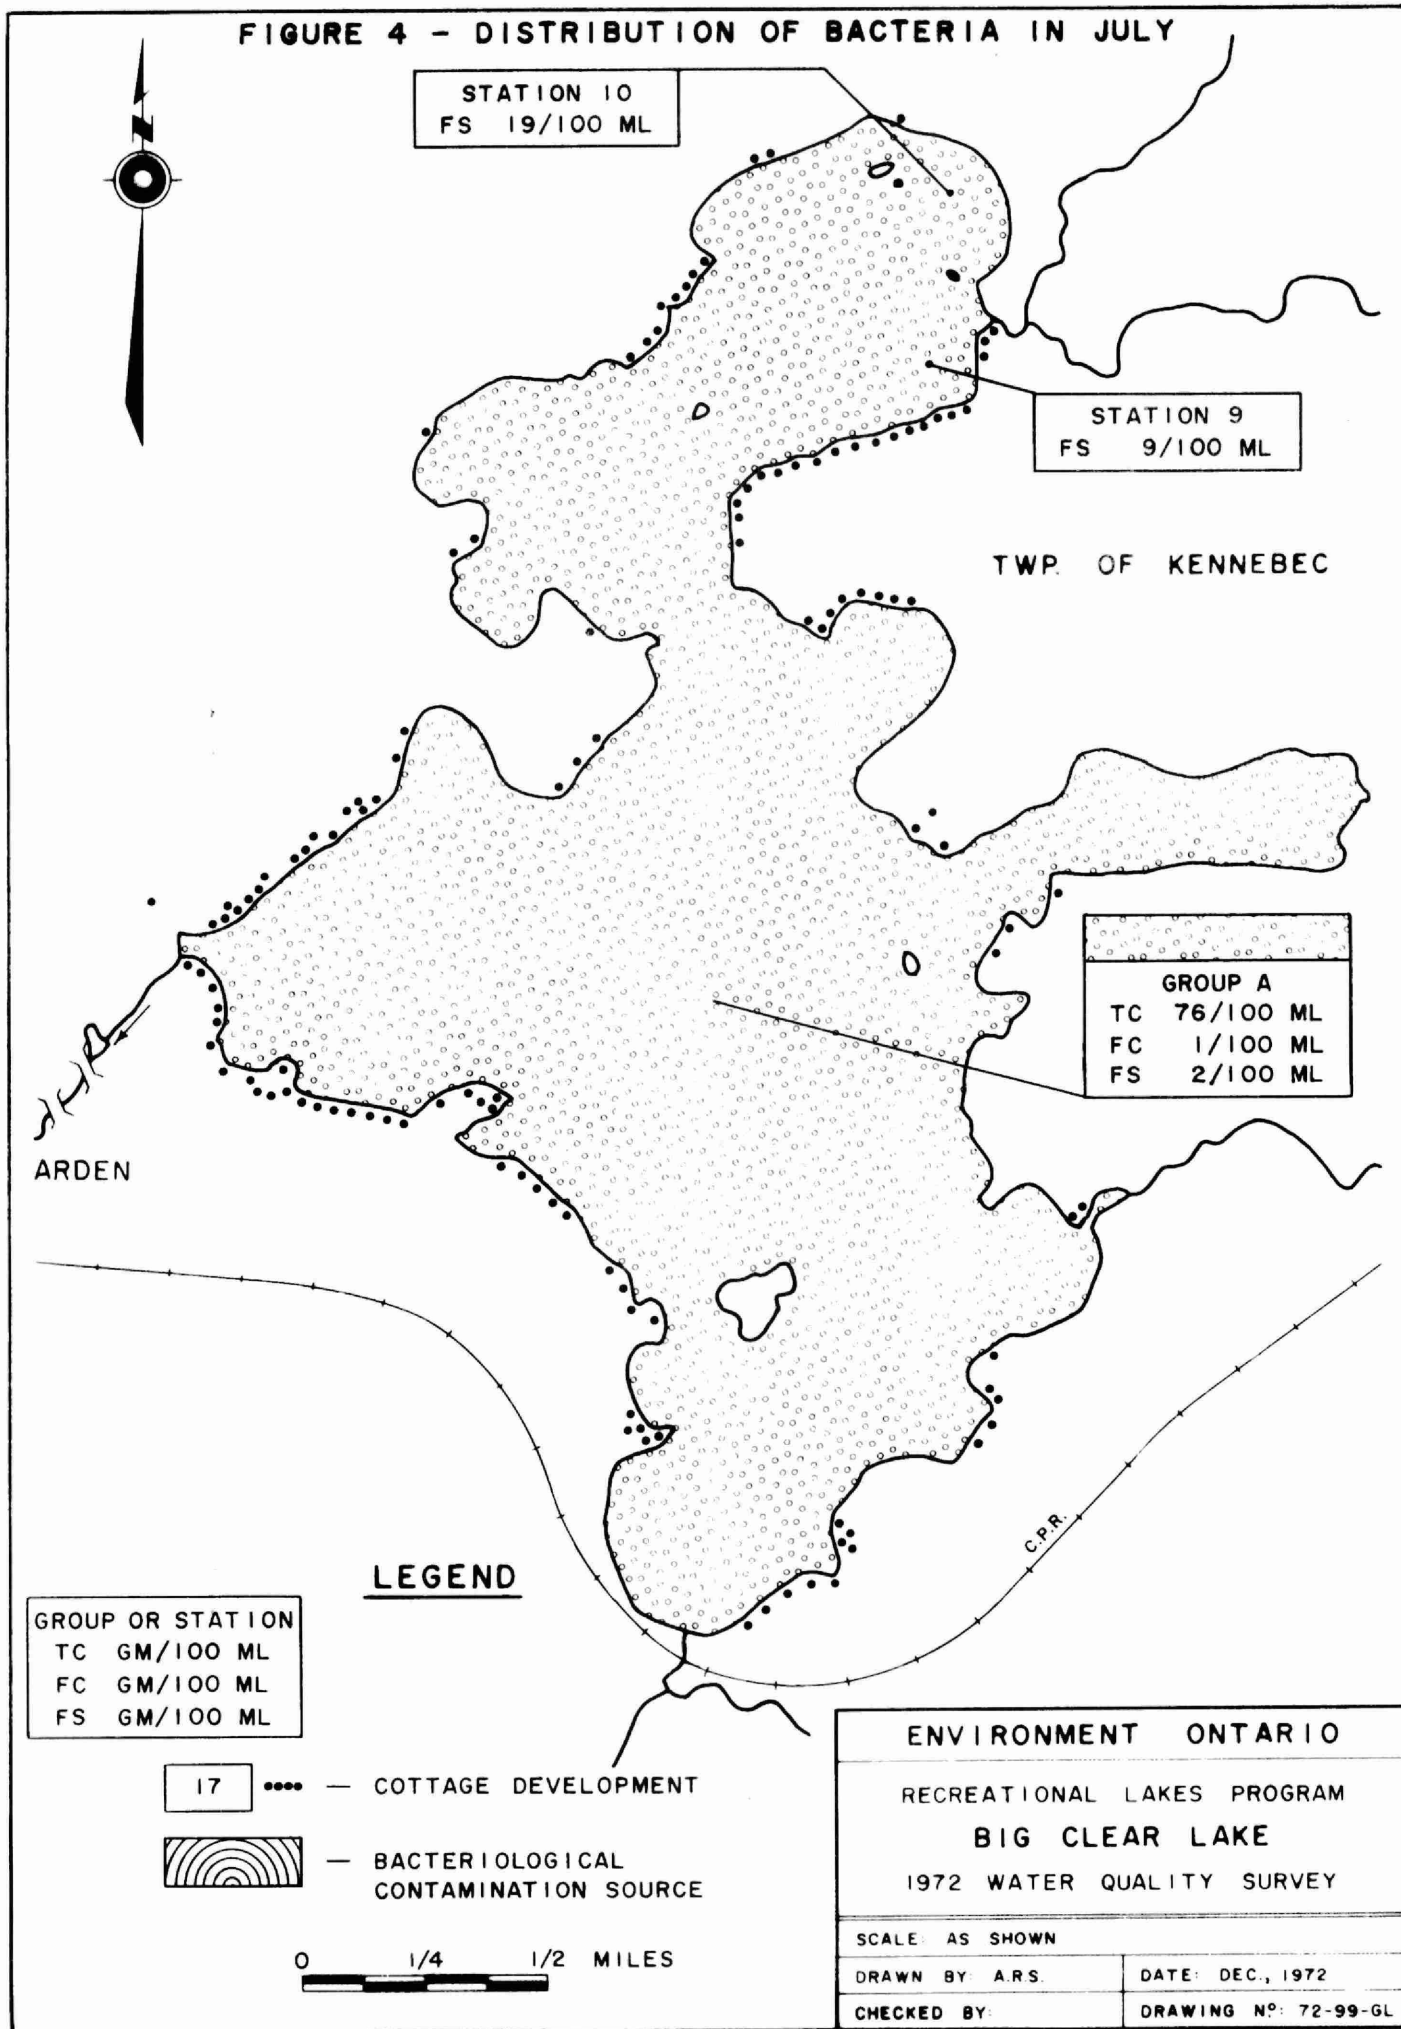
FIGURE 4 - DISTRIBUTION OF BACTERIA IN JULY

In the July - August survey, TC, FC, and FS mean values were 76, 1 and 2/100 ml respectively and except for Stations 9 and 10, with 9 FS and 19 FS/100 ml the lake was homogeneous with good water quality (Figure 4).

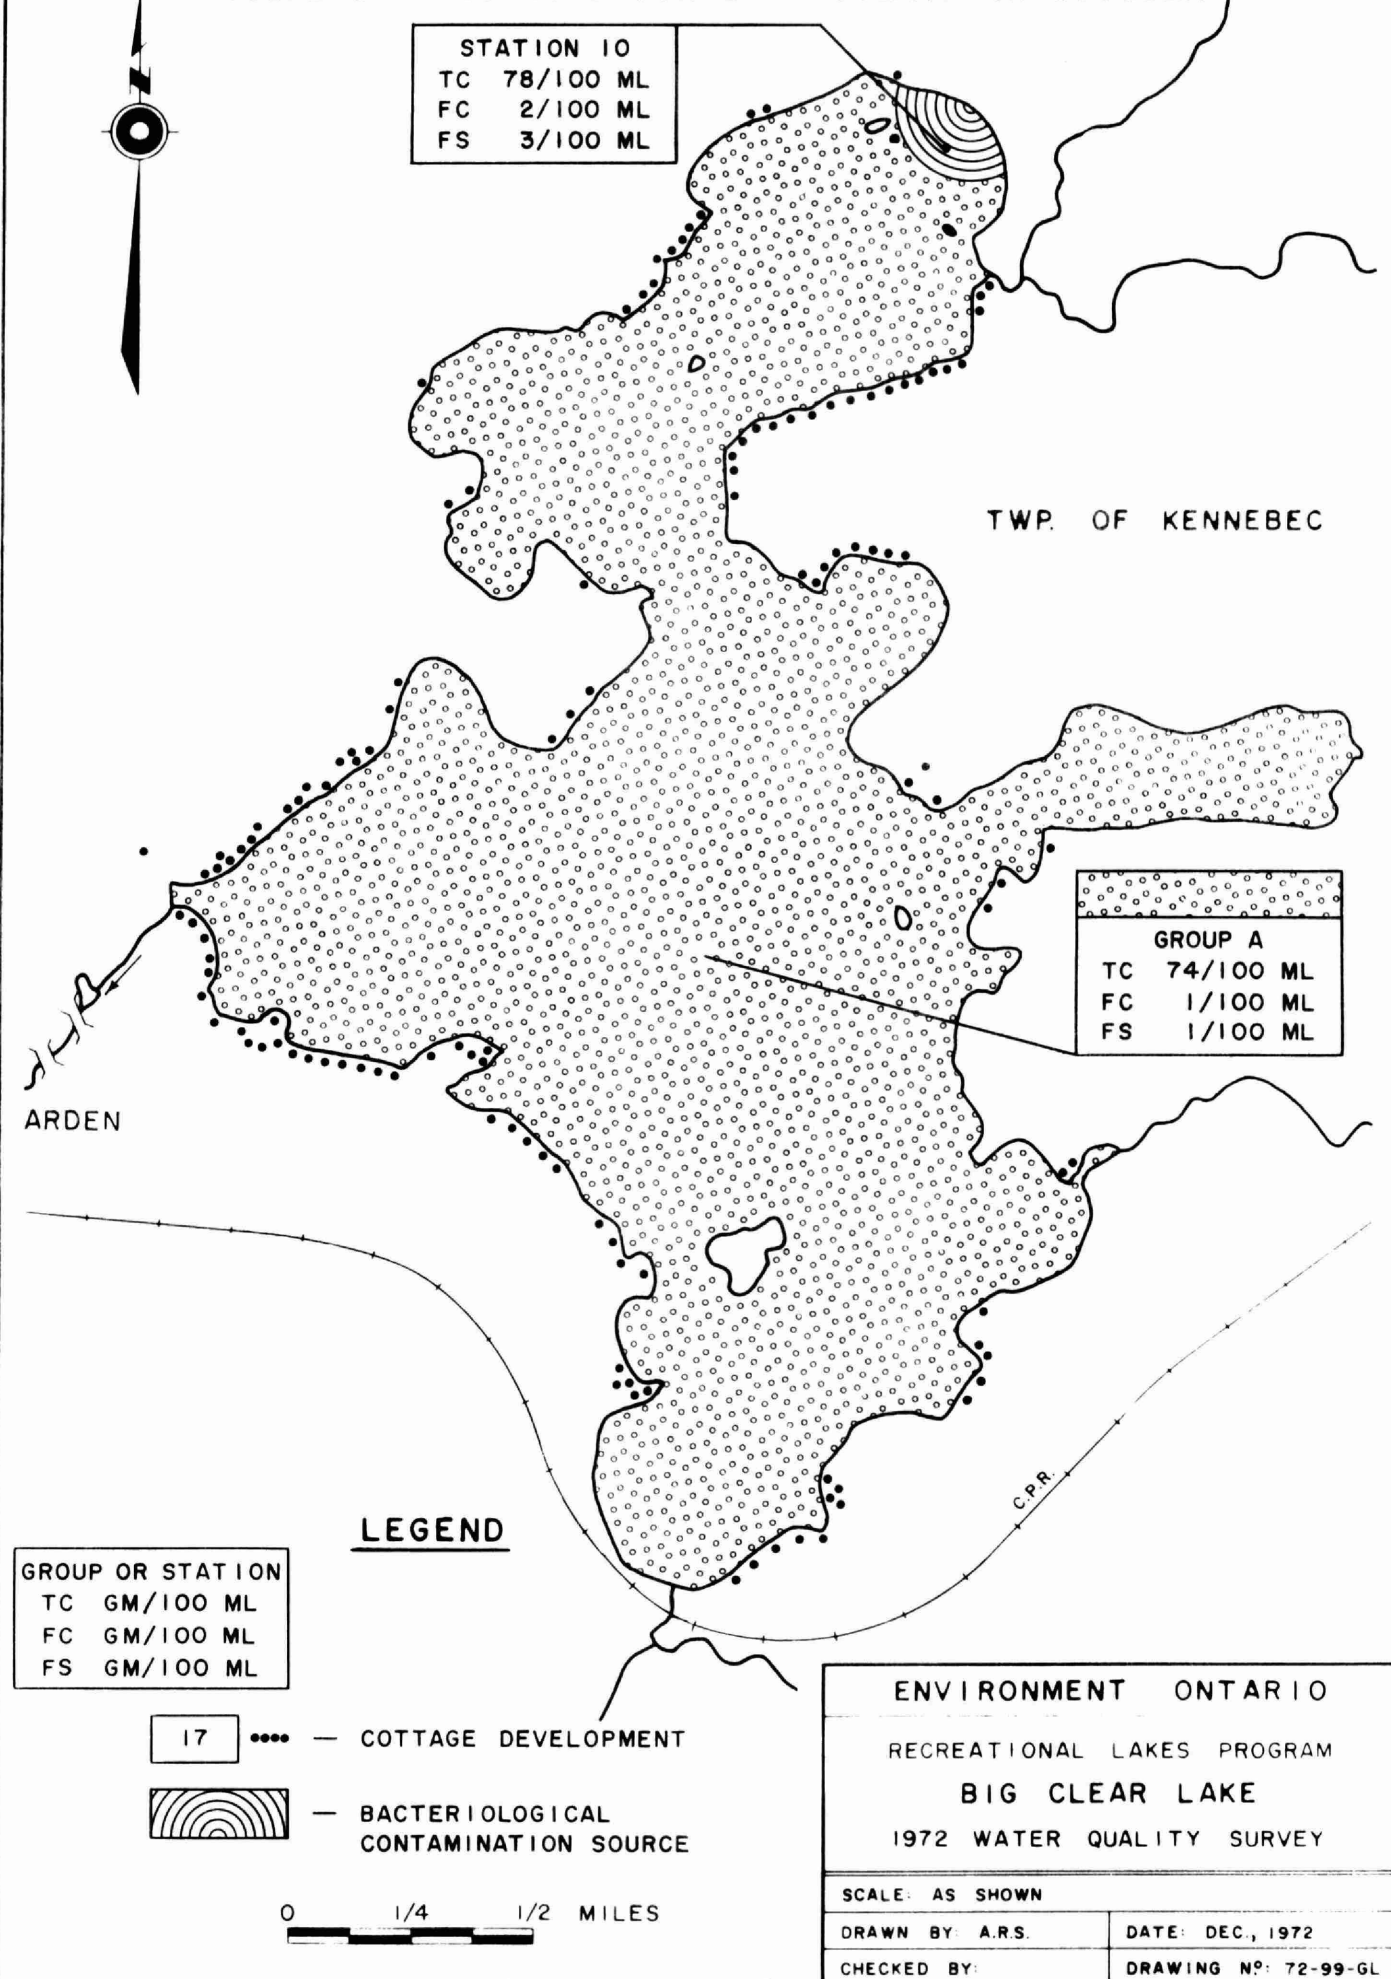
FIGURE 5 - DISTRIBUTION OF BACTERIA IN OCTOBER

In October, Big Clear Lake was again homogeneous with TC, FC, and concentrations of 74, 1 and 1/100 ml respectively which very closely approximated those of the summer survey. The north-east section of the lake with light cottage development (Station 10) had slightly higher bacterial levels than the rest of the lake (Figure 5).

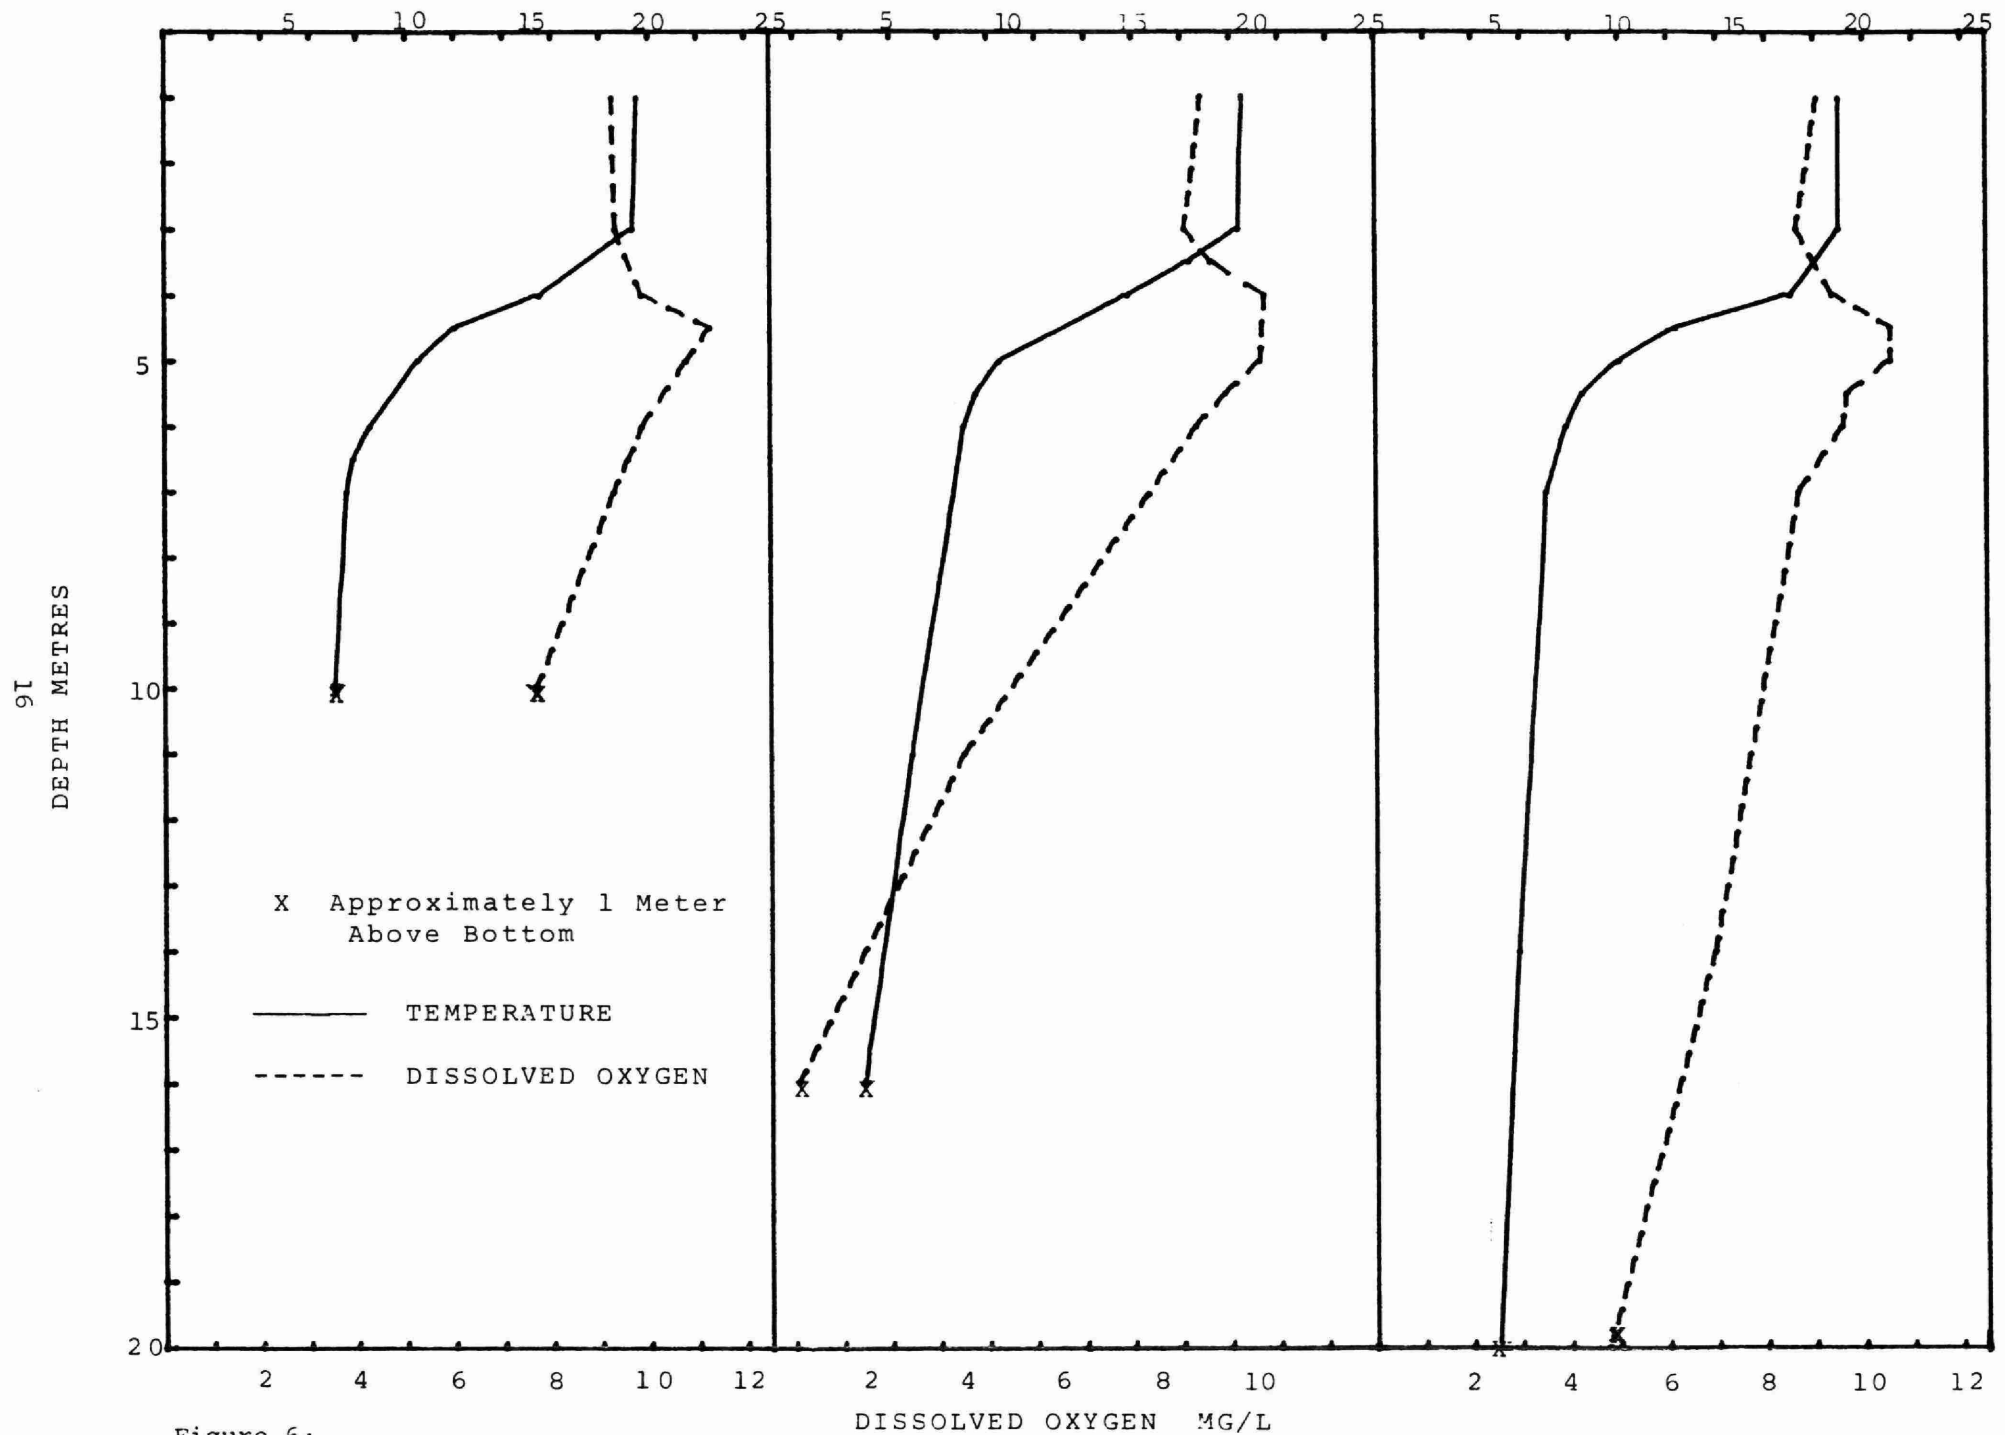
Figure 6:

Temperature and dissolved oxygen profiles for the June survey are shown in Figure 6 for the three deepest stations sampled. Station 11 shows the lowest residual dissolved oxygen in the bottom waters, 0.5 mg/1, while stations 5 and 16 show less depletion.

During the June survey, all three stations showed an increase in oxygen concentration at approximately 5 metres depth, which is probably an indication of increased algal activity at this depth. Station 16 showed progressive oxygen depletion through the August and October surveys (Figure 7). Station 5 showed the same depletion and by October the dissolved oxygen content below 12 metres at all three stations was less than 1 mg/1. Such low concentrations of dissolved oxygen render the bottom waters uninhabitable for cold water species of fish.

BIG CLEAR LAKE JUNE 9, 1972

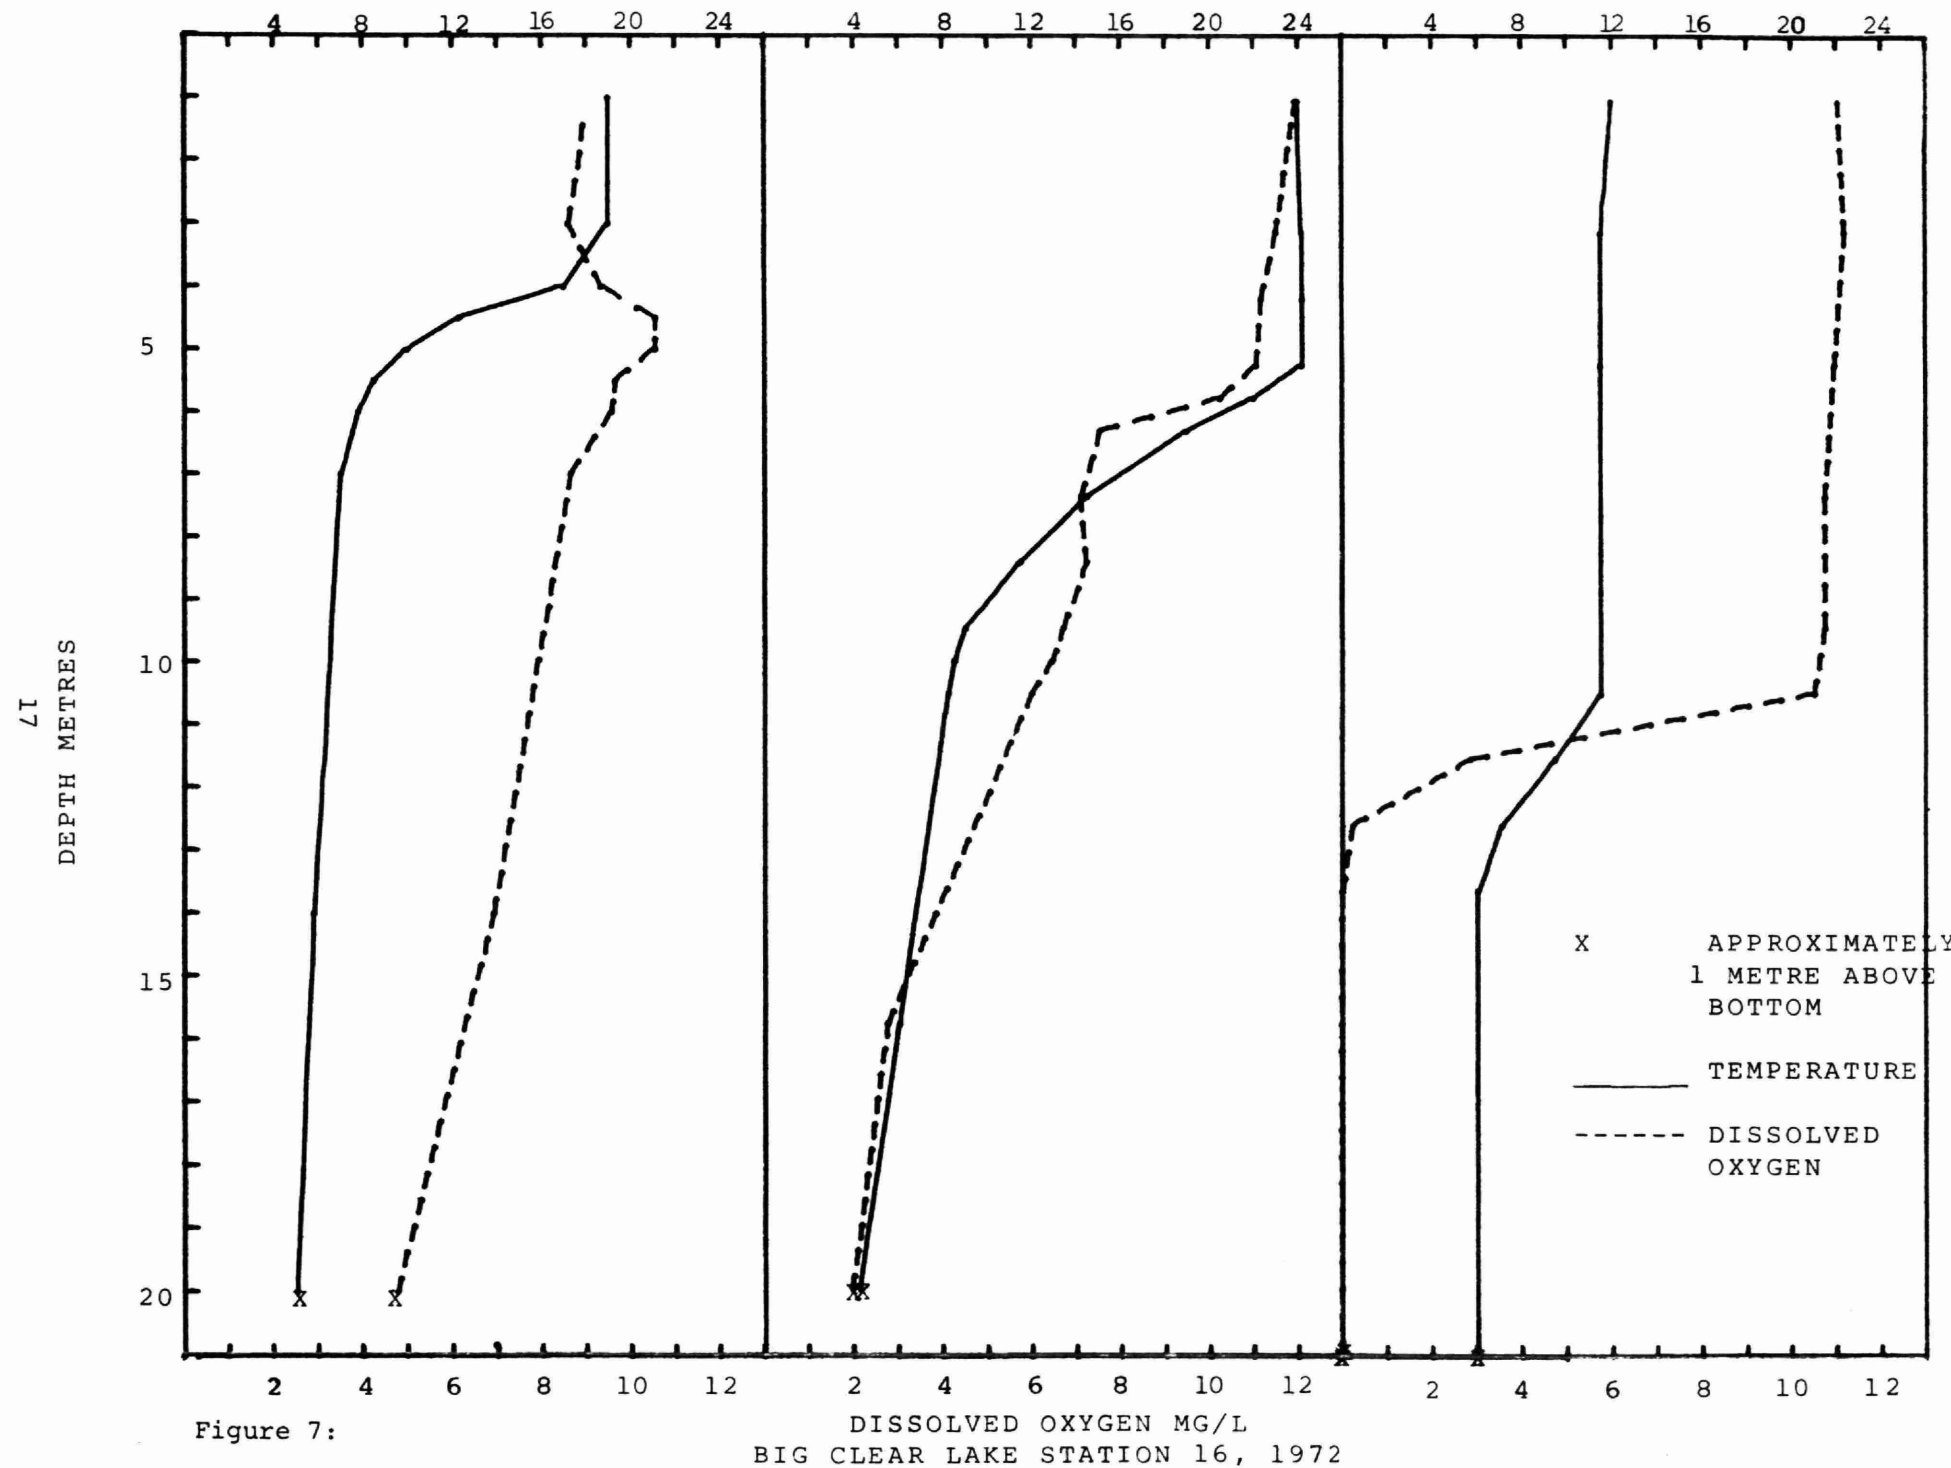
Figure 7:

DISSOLVED OXYGEN MG/L
BIG CLEAR LAKE STATION 16, 1972

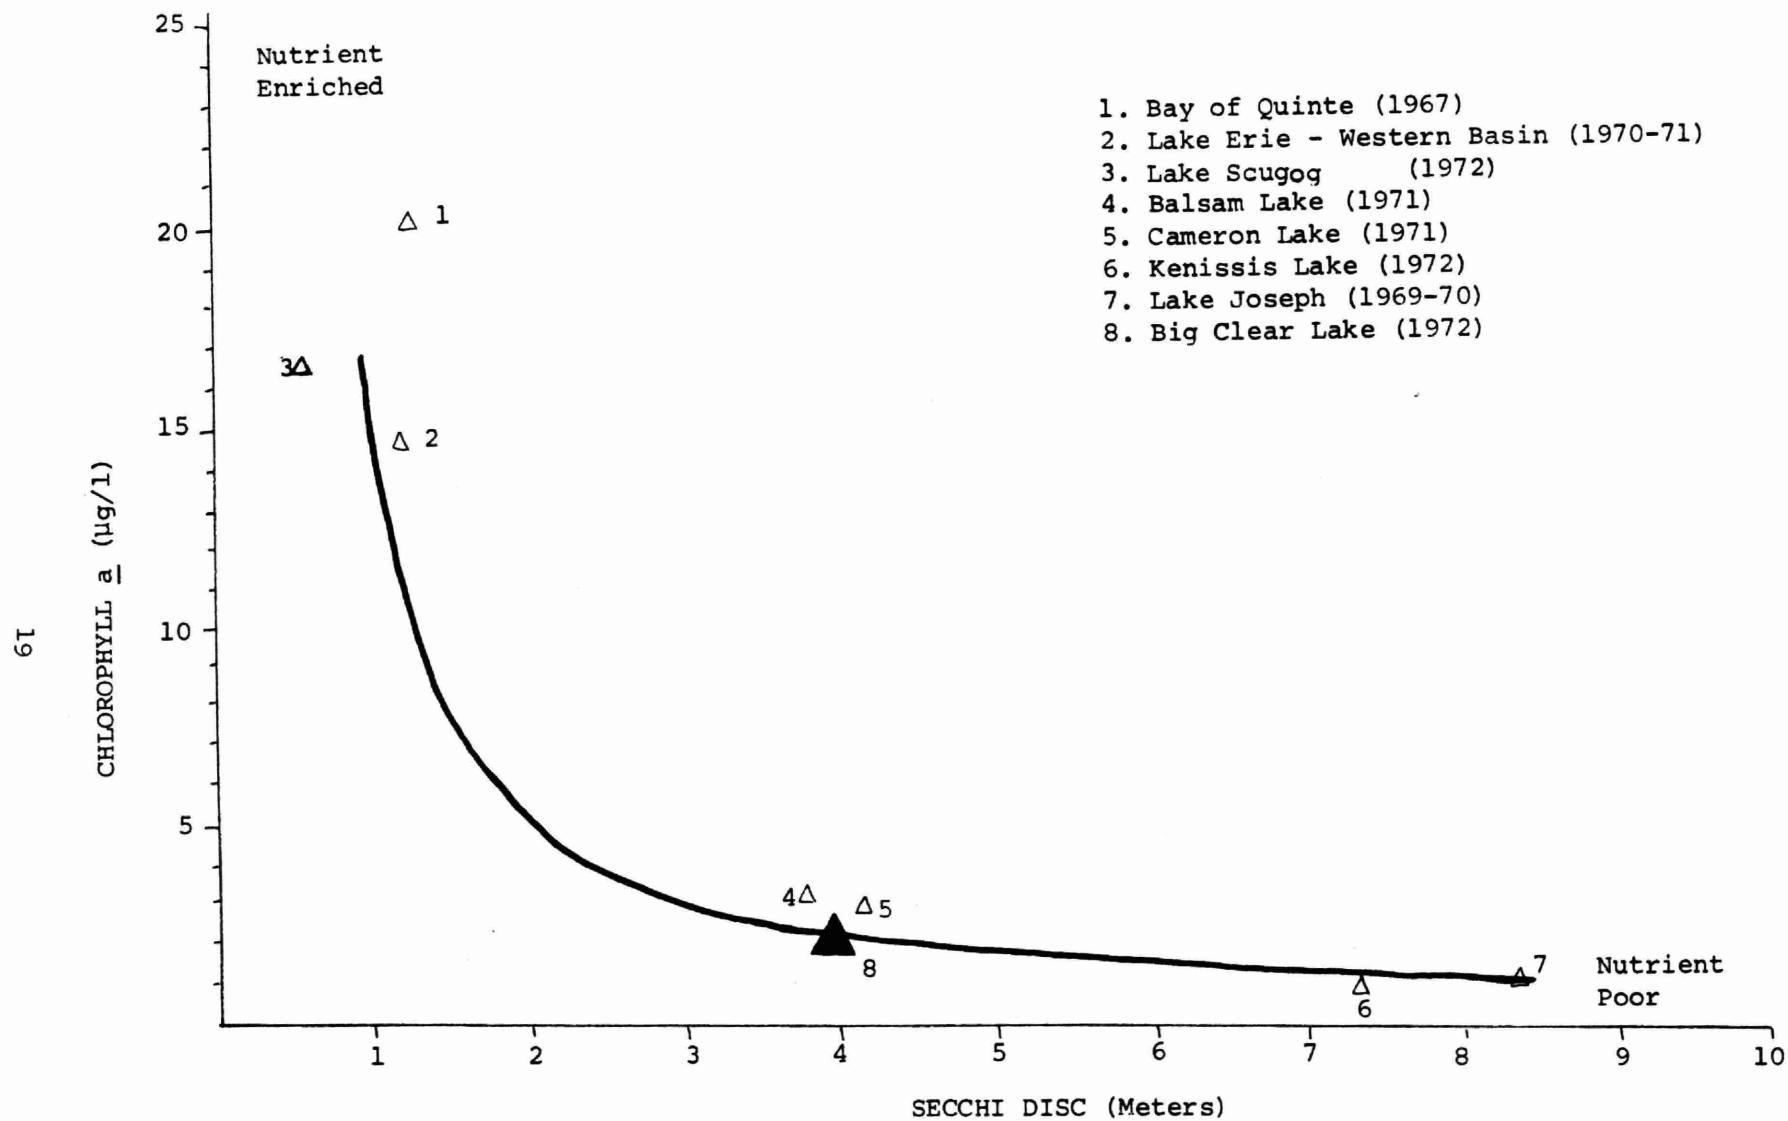
Cameron Lakes - two relatively clear water lakes (Figure 8). It is far removed from such highly enriched and therefore turbid lakes as the Bay of Quinte, the Western basin of Lake Erie and Lake Scugog (Figure 8) which are less transparent as a result of greater amounts of suspended algae.

Figure 8 : The mean of chlorophyll a and Secchi disc measurements in Big Clear Lake relative to a curve describing the chlorophyll a - Secchi disc relationship in many Ontario lakes. Seven other well known lakes are included for comparison with Big Clear Lake.

On a scale of lake enrichment as indicated by chlorophyll a concentrations and water transparency, Big Clear Lake is similar to Balsam and

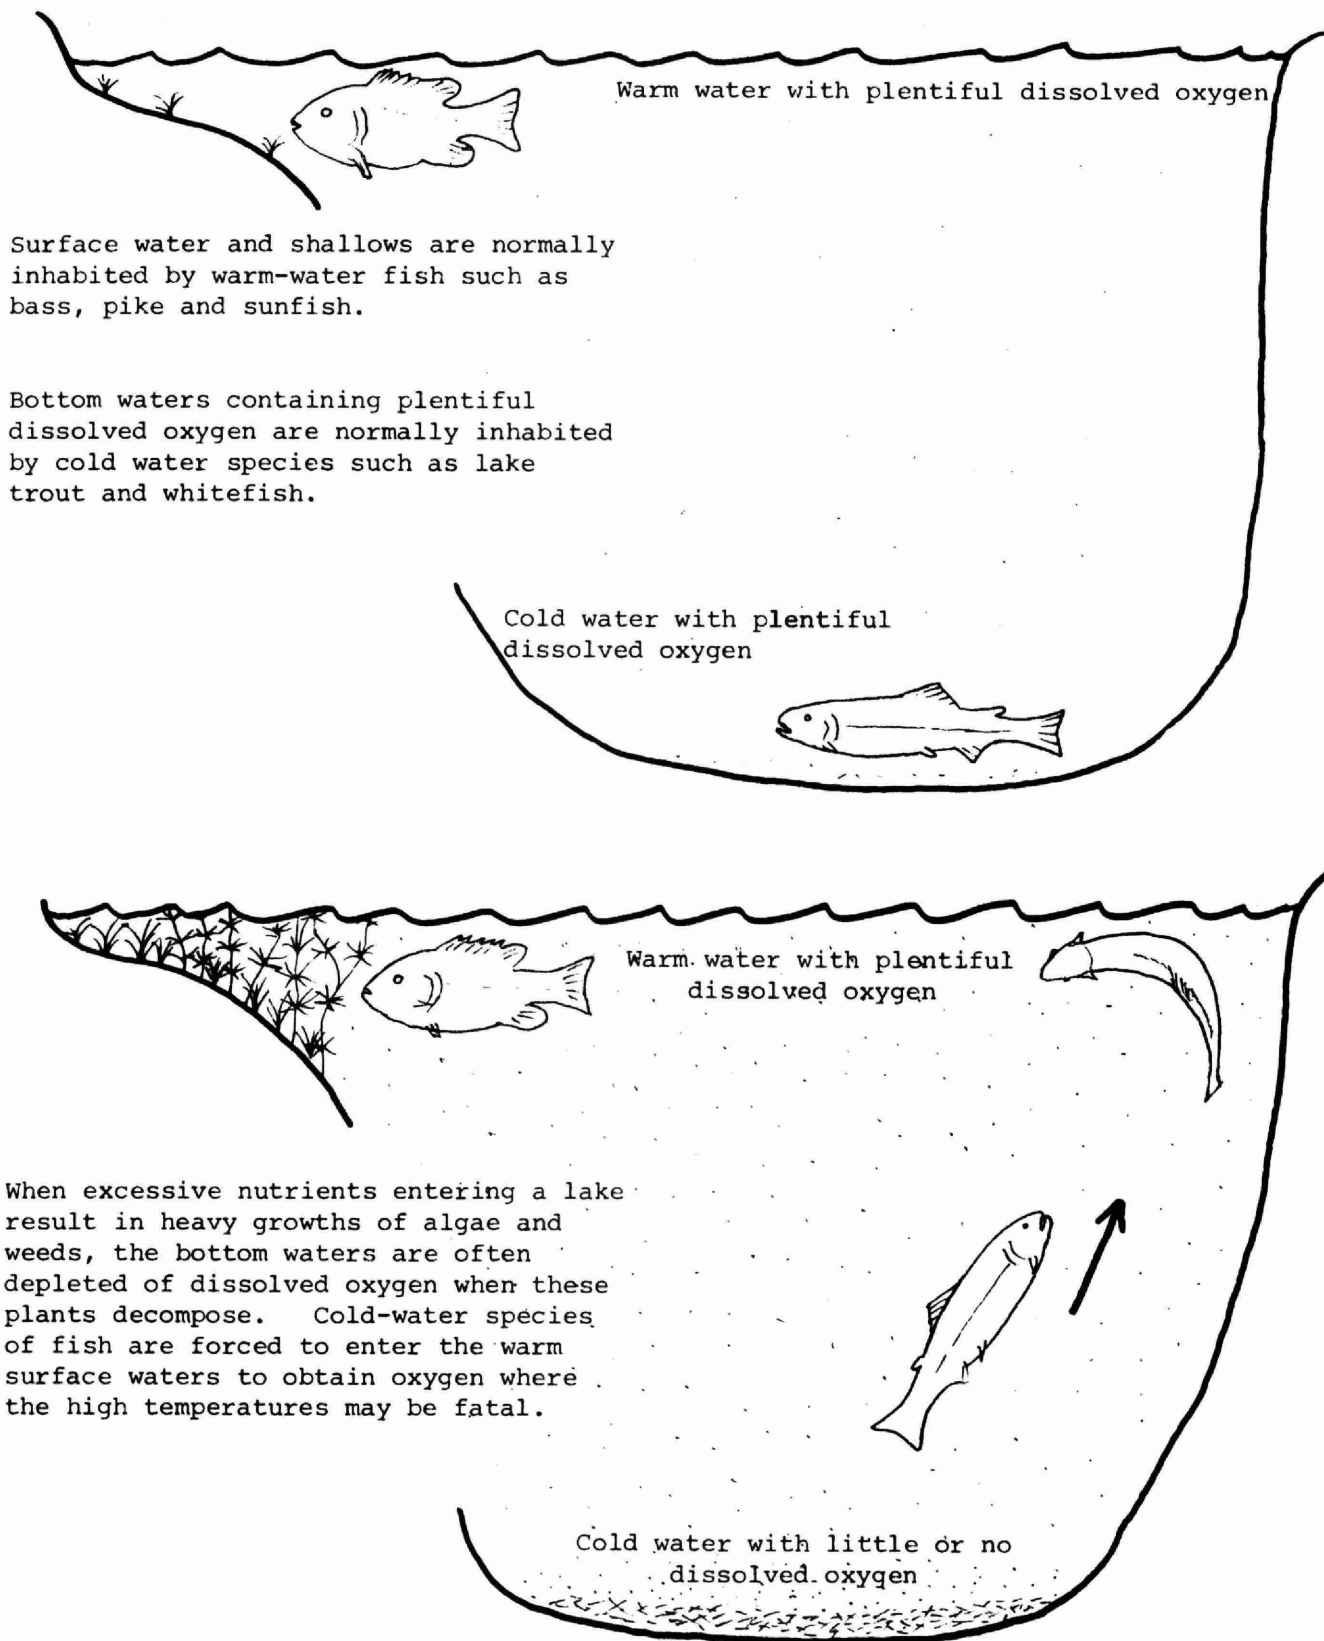
FIGURE A-1: DECOMPOSITION OF PLANT MATTER AT THE LAKE BOTTOM CAN LEAD TO DEATH OF DEEP-WATER FISH SPECIES.

Low oxygen conditions in the bottom waters are not necessarily an indication of pollution but excessive aquatic plant and algae growth and subsequent decomposition can aggravate the condition and in some cases can result in zero oxygen levels in lakes which had previously held some oxygen in the bottom waters all summer. Although plant nutrients normally accumulate in the bottom waters of lakes, they do so to a much greater extent if there is no oxygen present. These nutrients become available for algae in the surface waters when the lake mixes in the fall and dense algae growths can result. Consequently, lakes which have no oxygen in the bottom water during the summer are more prone to having algae problems and are more vulnerable to nutrient inputs than lakes which retain some oxygen.
